THE BASEMENT OF THE SAN FRANCISCO CHURCH: AN EARTHQUAKE-RESISTANT FOUNDATION ON A PREHISPANIC LAYER?

How has a four-century old church managed to stand on its feet, resisting more than 15 earthquakes of magnitude over 7?

Starting from this question, this research examines the church's subsoil to suggest that its foundations, built in 1586, perhaps would be one of the first earthquake-resistant structures in Chile.

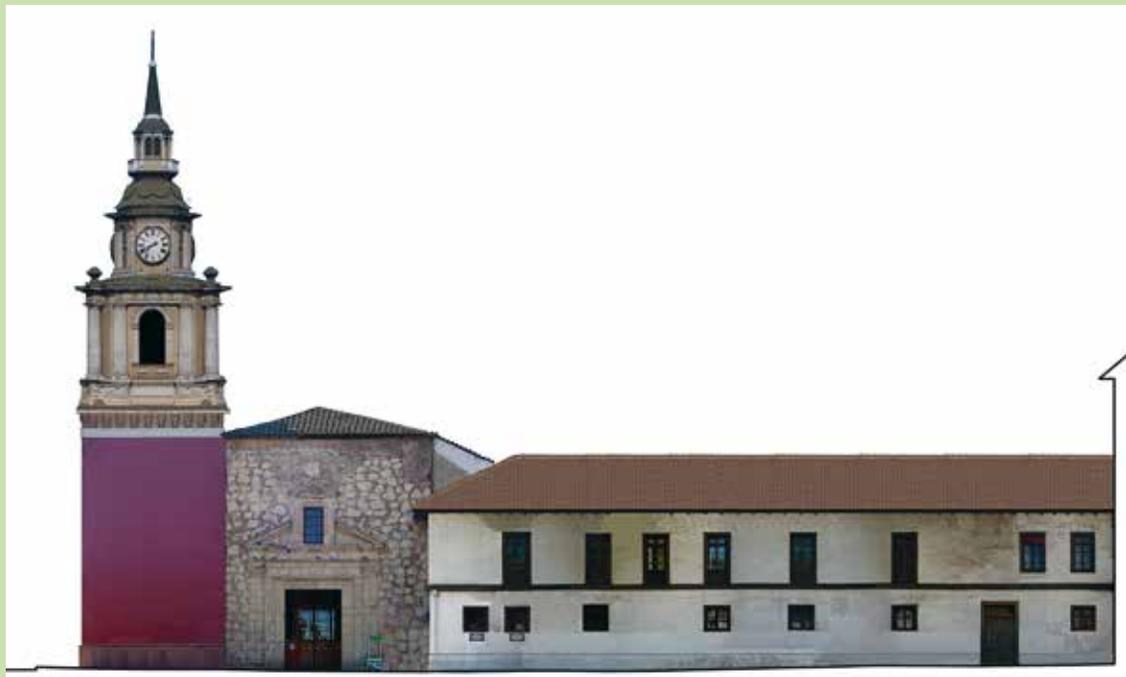
FIG 1 Fotogrametría elevación poniente Iglesia y Convento San Francisco /
Photogrammetry west elevation San Francisco Church and Convent.
Escala / Scale 1: 500. Fuente / Source: FONDECYT N° 11130628

The San Francisco Church and Convent in Santiago comprise both the capital's and the country's oldest built complex (FIG. 1),¹ being "the only authentic sixteenth-century architectural testimony preserved in Chile" (Benavides, 1988:128). The building, which has undergone numerous alterations, still preserves its original Latin-cross shaped stone structure (FIG. 2), an element that today constitutes the church's central nave and transept (FIG. 3).

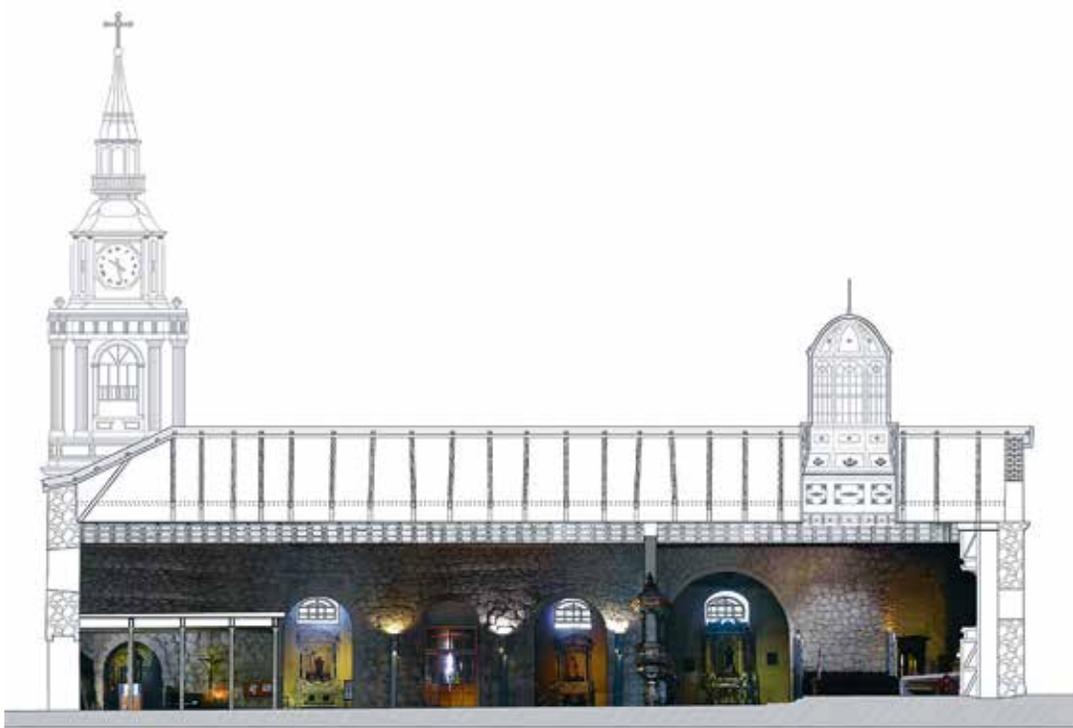
FIG 3 Corte fotogramétrico longitudinal iglesia San Francisco. Nave central original. /
Photogrammetric longitudinal section San Francisco Church. Original central nave.
 Escala / Scale 1:500. Fuente / Source: FONDECYT N° 11130628

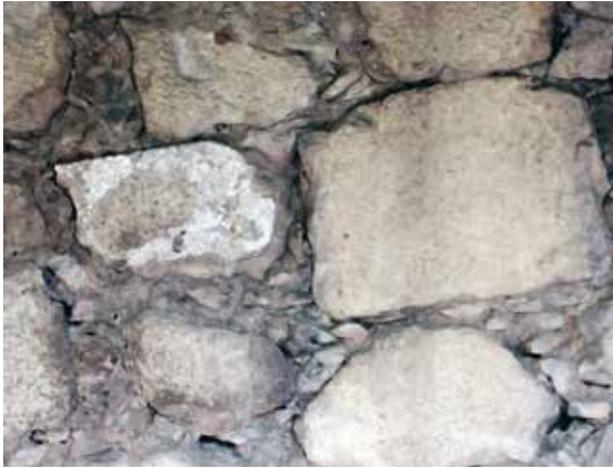
FIG 4a Detalle mampostería de piedra original / *Original stone masonry detail.*
Fuente / Source: FONDECYT N° 11130628

Thus, although the church has been modified and shows partial damage of seismic origin, these have been minor. This, despite the apparent fragility of the constructive systems employed, consisting of stone masonry in the original nave and brick masonry in the aisles (FIG. 4); basically, systems with low capacity to resist horizontal forces.

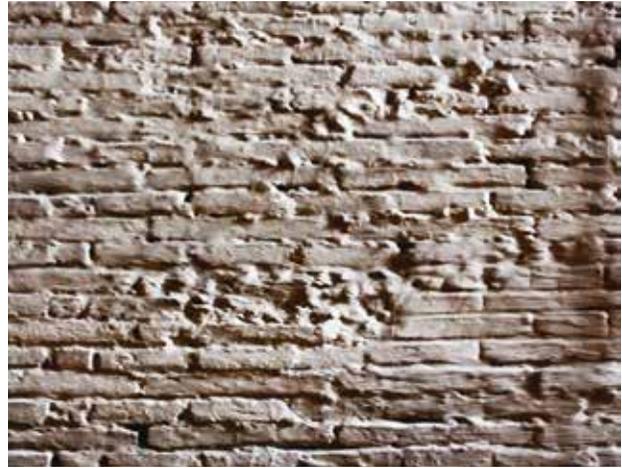
FIG 4b Detalle albañilería de ladrillo de las naves laterales, de construcción posterior / *Masonry brick detail in side aisles, of later construction.* Fuente / Source: FONDECYT N° 11130628

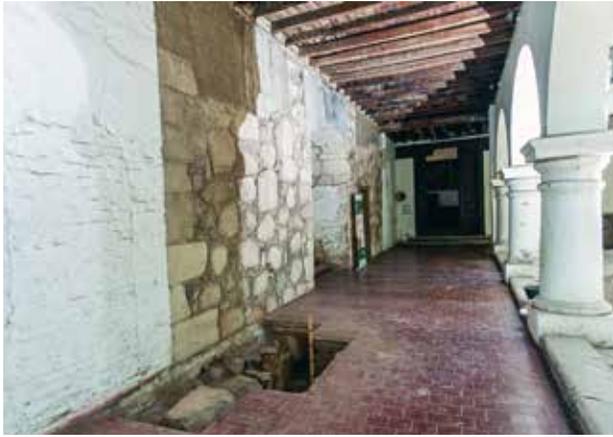
FIG 7 Ubicación de la excavación en el actual corredor del Museo / Location of the excavation in today's Museum's corridor. Fotografía / Photograph: Claudio Zamorano. Fuente / Source: FONDECYT N° 11130628

excavation area (FIG. 6), a place where the church's southwest corner used to be and where the San Francisco Colonial Art Museum's corridor is today (FIG. 7). This specific location was chosen considering that the transept corresponds to the church's original stage and that it has never collapsed with earthquakes or been modified; therefore, the foundations to be found here could be representative of the church's entire first phase. The excavation polygon was entitled Unit 1; subsequently, due to the findings –the atypical characteristics of the foundation and also human remains– it was decided to extend it to more than twice its size, about 4 linear meters by 1 meter wide and 1.5 meters in the burial area. The excavation's enlargement area was called Unit 2, while the burial area was called Burial 1 (FIG. 8).

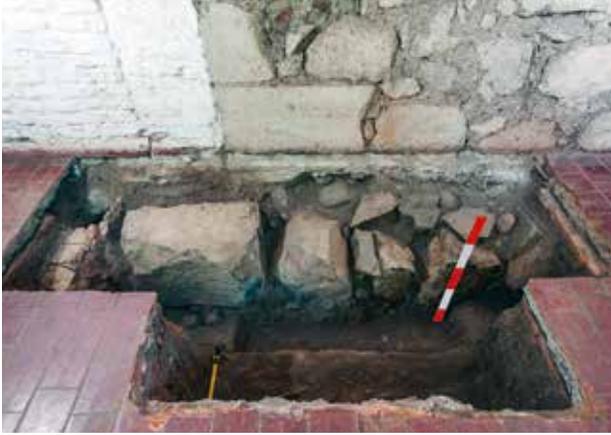
FIG 9 Vista frontal del sistema de cimientos / *Front view of the foundation system.* Fuente / *Source:* FONDECYT N° 11130628

The foundations of the original San Francisco church constitute an atypical case and, therefore, are dissimilar from most colonial buildings in Santiago. Their structure starts 10 cm below floor level –where the 1.7 m thick stone wall ends– and is made of cobblestone ('boulders' in colloquial language), contained laterally by two megalithic stone axes. Cobblestones –likely extracted from the Mapocho river– vary in size, ranging between 10 and 30 cm, and are submerged in loose soil and sand; that is, they are not bounded by mortar and, therefore, they have no rigidity. This means that the thick wall is simply rests on a sort of mobile support. The lateral axes –of which only one was observed during the excavation– are composed of large semi-shaped stone blocks about 60 × 60 × 60 cm, parallel to the foundations and detached 20 cm from the wall, with a larger stone (90 × 60 × 60 cm) located at the corner of the transept. At the junction between the large blocks are small cobblestones and wedge-shaped stones, presumably to keep together the ensemble, transforming the axis into an immovable lateral retaining wall (FIGS. 9-10).

Given the impossibility of excavating inside the church, a georadar⁸ was used to verify the existence of an identical axis on the inner side of the walls; this analysis showed an abnormality in the subsoil which could be interpreted as the inner lateral axis. This means the foundations form a 'seismic isolator' where the cobblestones can move freely during an earthquake without neither crumbling nor losing their geometry as they are contained on both sides (FIG. 11). Thus, this system partially isolates the structure from ground movements, reducing the horizontal effort that could affect the building. In all likelihood this foundation system is the

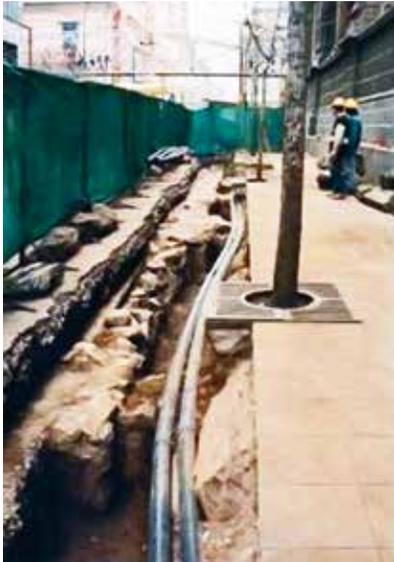
FIG 12a Cimientos de piedra con argamasa de cal de la Catedral de Santiago / Stone and lime-mortar foundation of Santiago's Cathedral. Fotografía / Photograph: Claudia Prado. Fuente / Source: FONDECYT N° 1090325

It is noteworthy that although the use of cobblestones in foundations was relatively common during the colonial period, these were used in the deepest part as filling material –immediately above the soil– and if they were more superficial or near the wall, they would be bound by mud or lime and sand mortar. In addition, in monumental buildings in Santiago like the Cathedral, the Real Audiencia and the Real Aduana (current Museum of Pre-Columbian Art) it is usual to find great depth and thicker-than-walls foundations, built of stone or brick and mortar (FIG. 12). In other words, conventional foundations belonging to Spanish tradition.

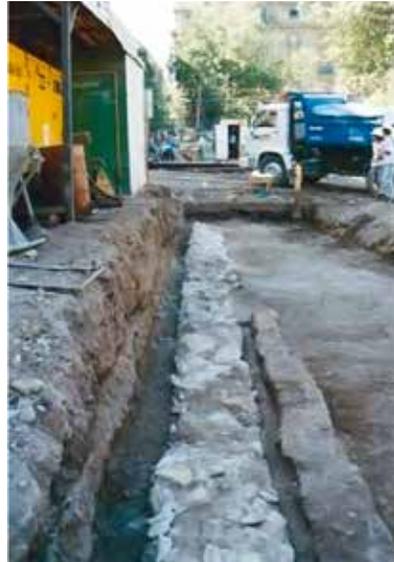
FIG 12b Cimientos de piedra con argamasa de cal del antiguo mercado de la Plaza de Armas de Santiago / Stone and lime-mortar foundation of Santiago's ancient market at Plaza de Armas. Fotografía / Photograph: Claudia Prado. Fuente / Source: FONDECYT N° 1090325

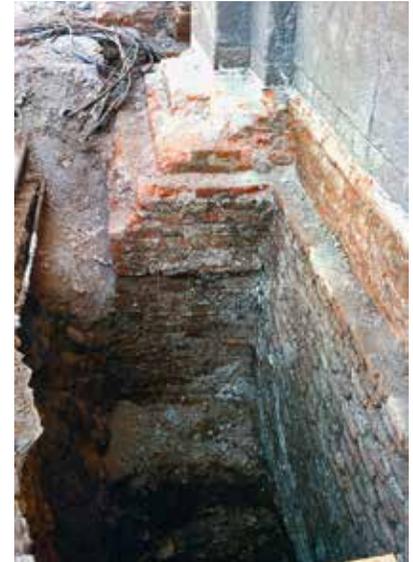
FIG 12c Cimientos de piedra con argamasa de la ex Real Audiencia de Santiago. Excavaciones realizadas en el marco de la construcción de la Estación Metro Plaza de Armas / Stone and mortar foundation of the former Real Audiencia in Santiago. Excavations performed during the construction of Plaza de Armas Subway Station. Fotografía / Photograph: Claudia Prado, 1997.
